University of Canterbury

Experimental Study on the Seismic Performance of Low Damage Systems for Non-structural Light Framed Plasterboard Partition Walls

ENEQ690 Master's Thesis

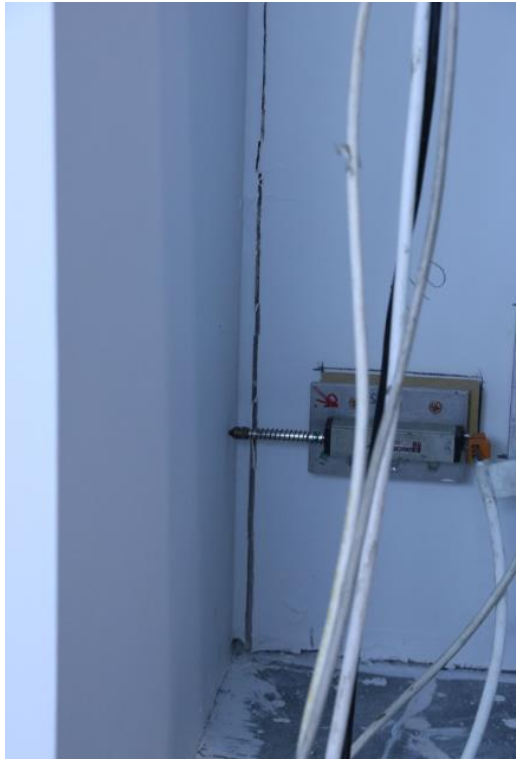
Figure C.38 Specimen B2 – Step 10 – DS1a: Debonding of gap-filler material at Y-junction - location 11 (photo taken during peak excursion)

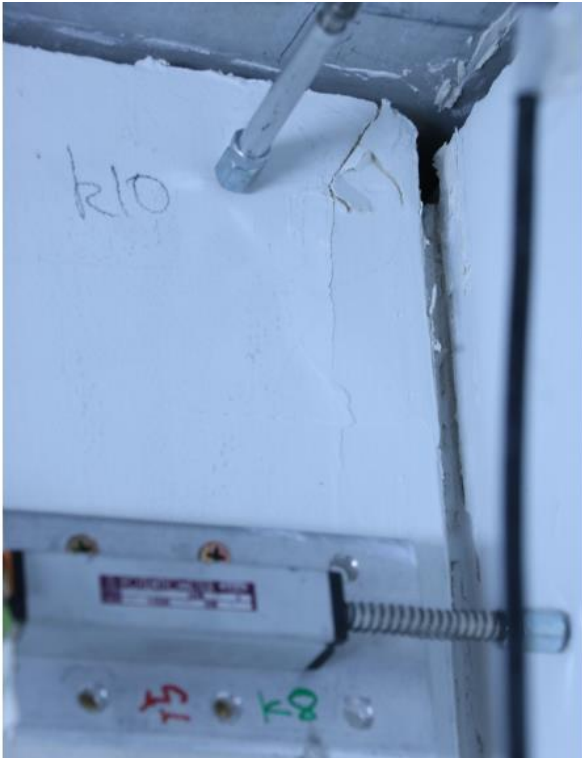
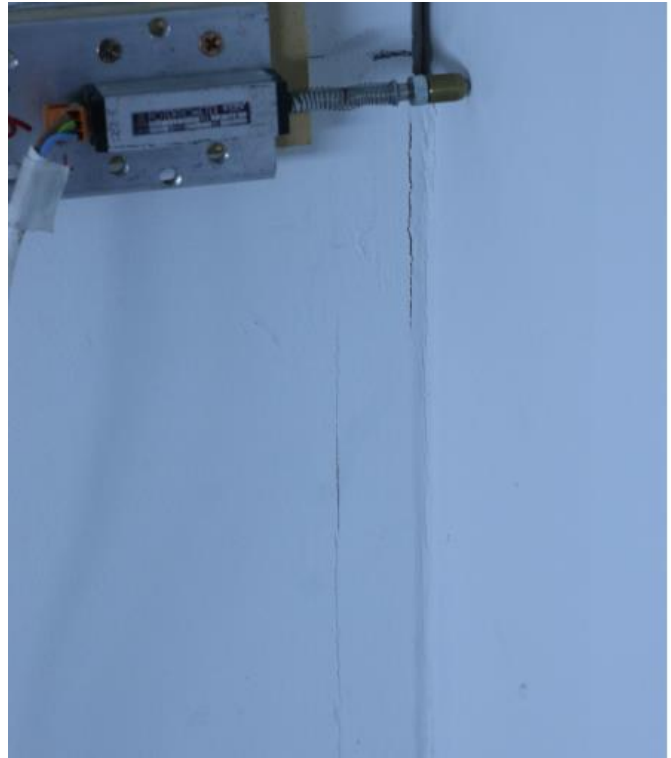
Figure C.40 Specimen B2 – Step 11 – DS1b: Plaster cracking along L-trim - location 111

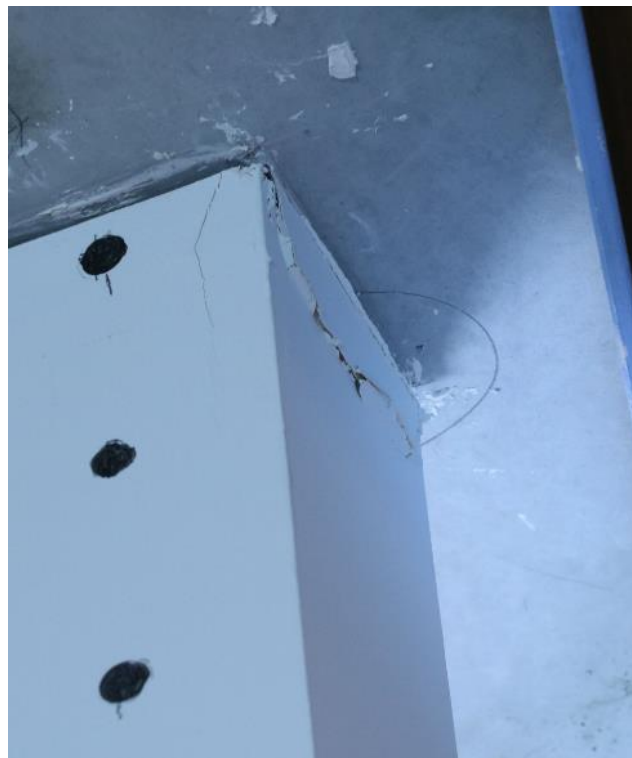
Figure C.41 Specimen B2 – Step 11 – DS1b: Plaster cracking along L-trim at wall end - location 21

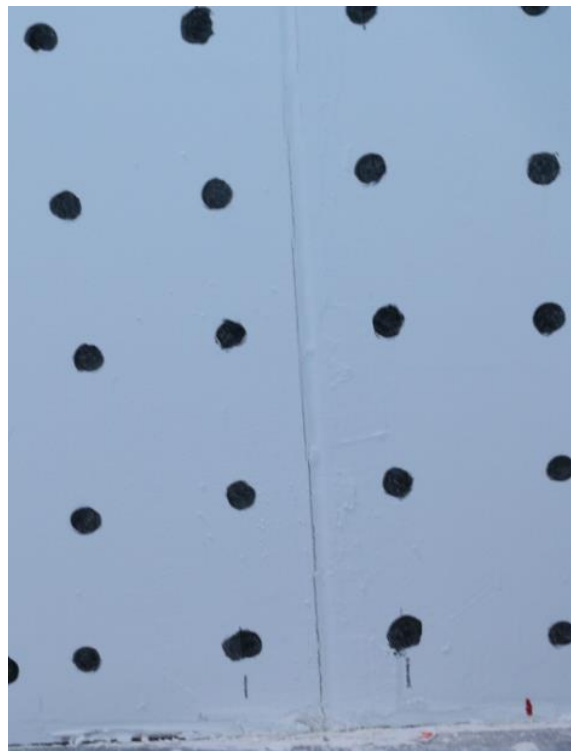
Figure C.43 Specimen B2 – Step 12 – DS1b: Gap filler material dedonding at intermediate joint – location 4

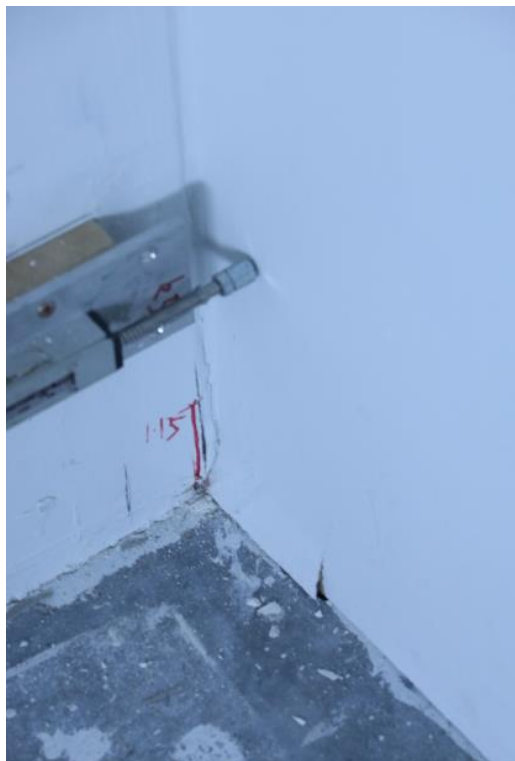
Figure C.45 Specimen B2 – Step 13 – DS2a: Wallboard damage in return wall at L-junction – location 10/11

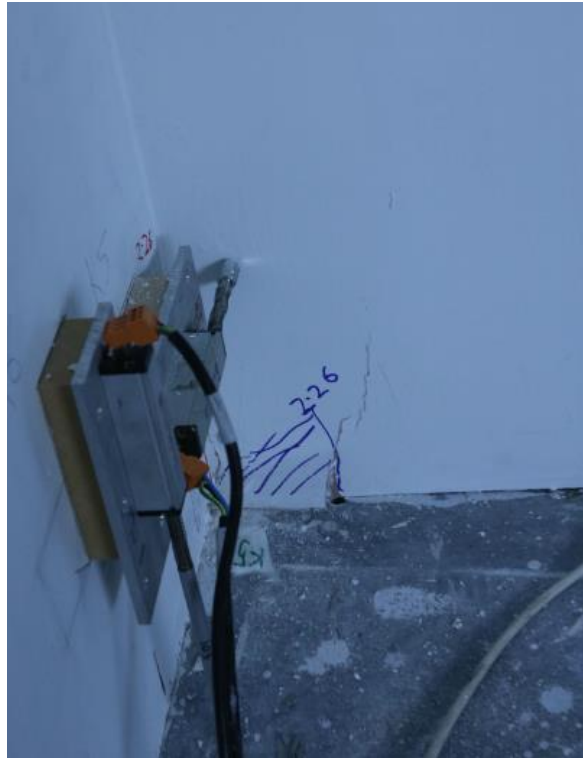
Figure C.48 Specimen B2 – Step 14 – DS2a: Wallboard crushing at toe at Y-junction – location 15

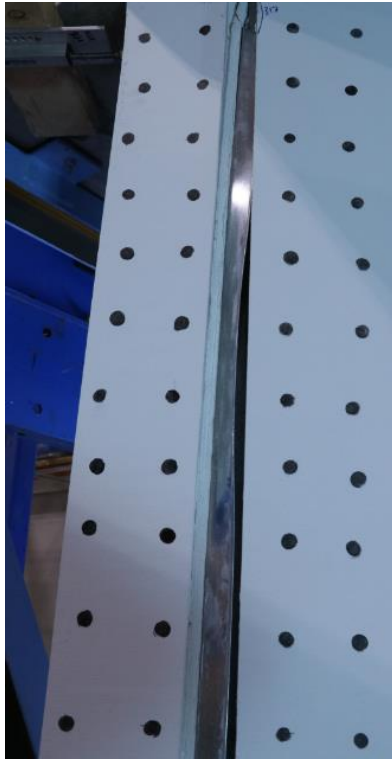
Figure C.50 Specimen B2 – Step 15 – DS2a & 3: Excessive residual gap development and bent flanges of vertical steel track – location 6

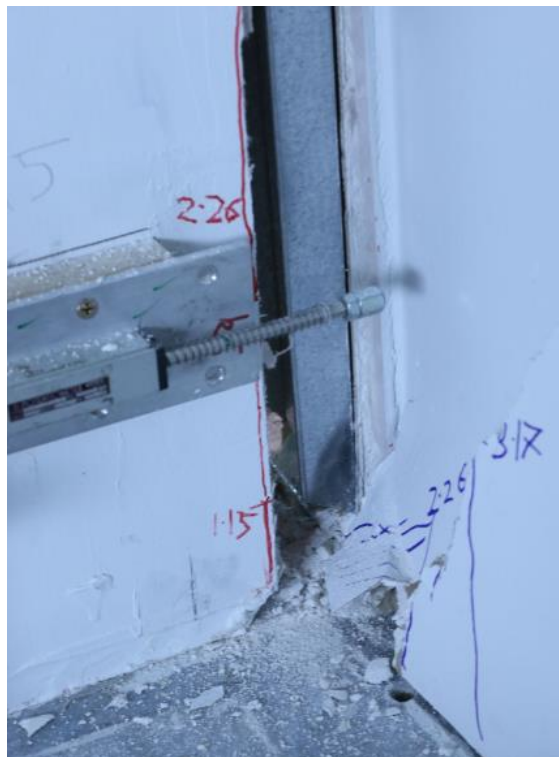
Figure C.51 Specimen B2 – Step 15 – DS2a & 3: Excessive residual gap development and bent flanges of bottom steel track in return wall – location 11

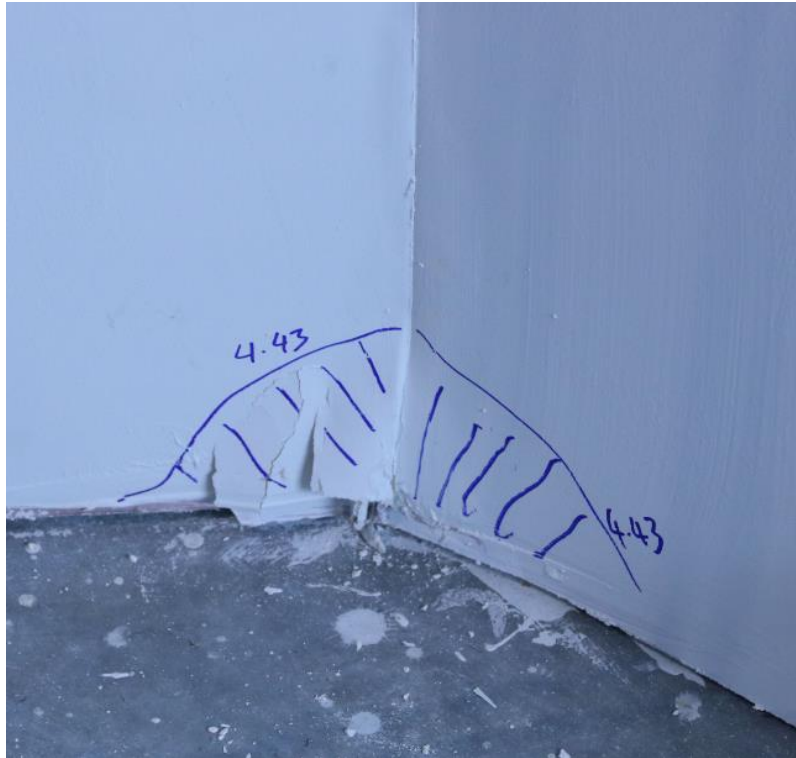
Figure C.52 Specimen B2 – Step 15 – DS2a: crushing of wallboard at the base of the Y-junction – location 19

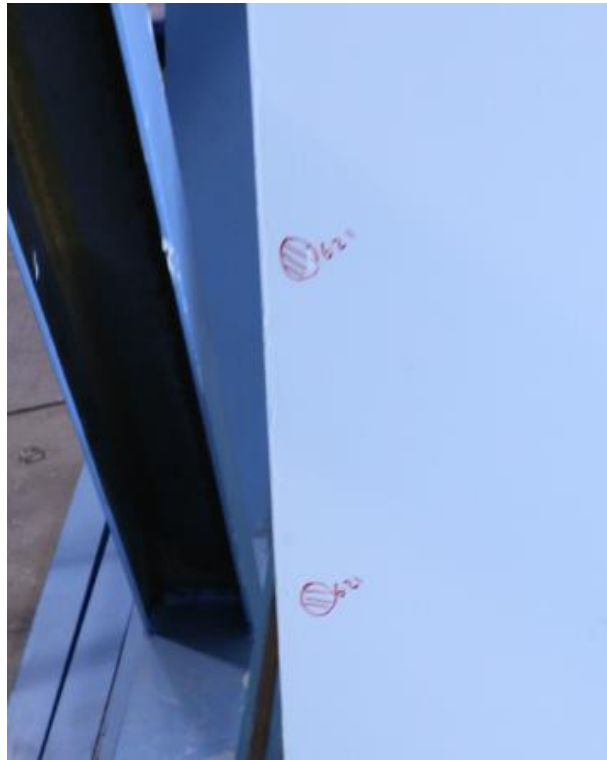
Figure C.54 Specimen B2 – Step 16 –DS1c: Popping out of screws along end stud– location 20/21

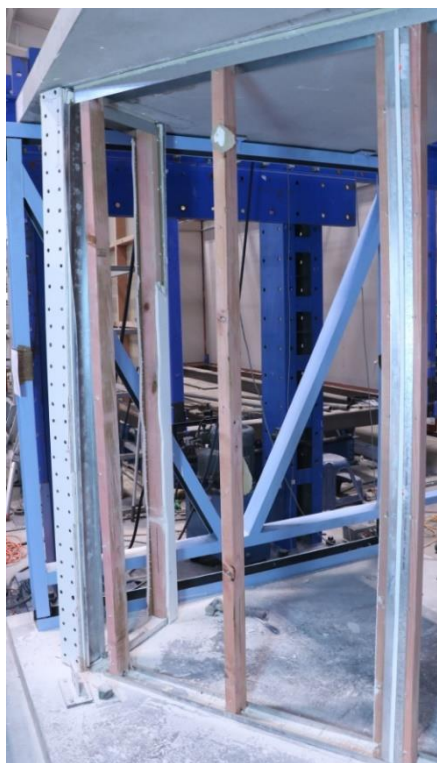
Figure C.57 Specimen B2 – Post-test framing inspection —showing timber studs mostly in good condition (could be re-used)

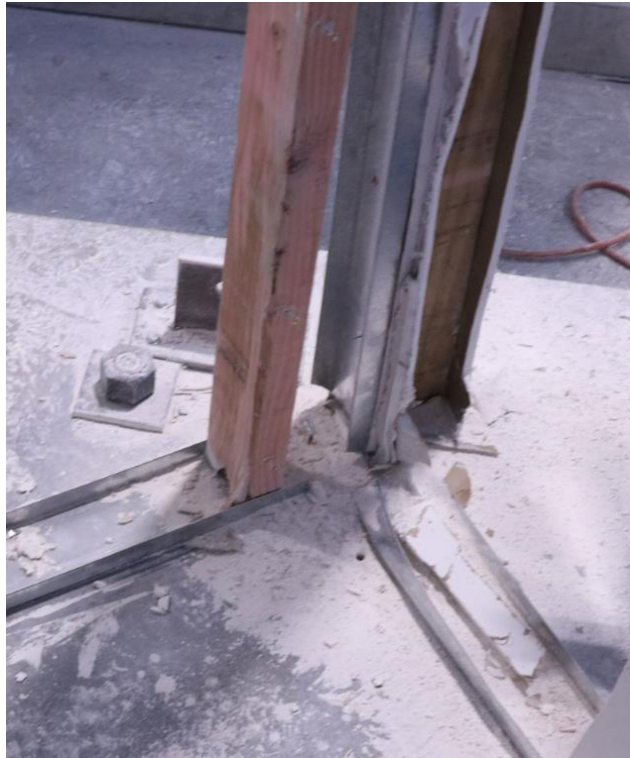
Figure C.58 Specimen B2 – Post-test framing inspection —bending of bottom track flanges in return wall at L-junction – locations 6, 7, & 11

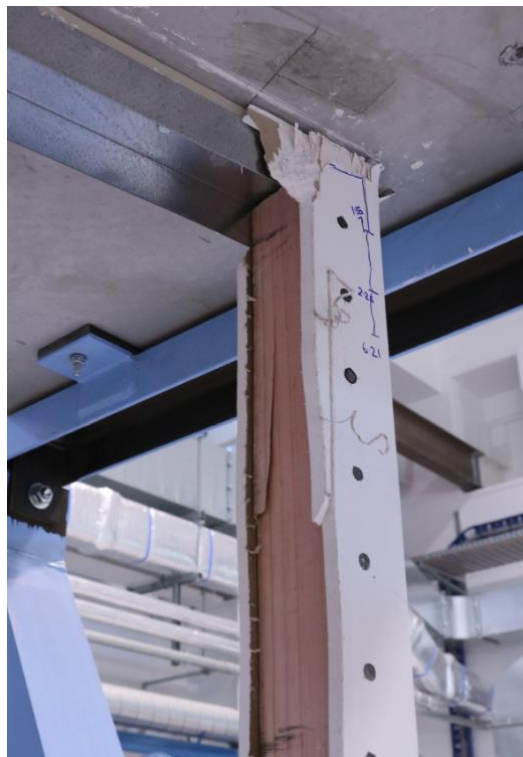
Figure C.59 Specimen B2 – Post-test framing inspection —Axial compression damage to timber stud at end of angled wall – locations 21

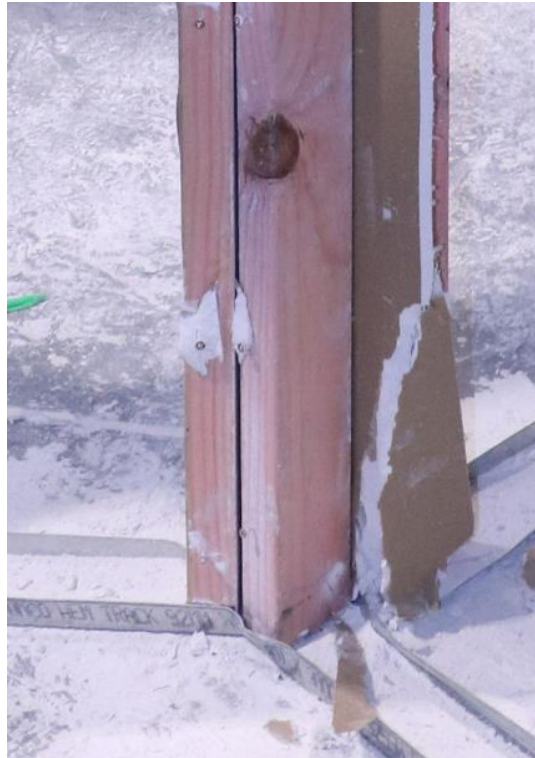
Figure C.60 Specimen B2 – Post-test framing inspection —bending of bottom track flanges due to pushing of the main wall against the Y- junction – locations 2, 15, & 19
